Title:	Full Mouth Rehabilitation – BDS5 Student Case Report
Type of article:	Case Report
Authors:	Dr Malikha Khan, General Dental Practitioner, malikhakhan680@gmail.com Dr Ali Nankali, Clinical Reader in Digital Dentistry, Teaching and Innovation Centre, 4 th Floor, 3 rd Office Barts and the London Medical Institute London E1 2AD
Contact Authors	malikhakhan680@gmail.com
Date of publication:	2024 08 01

Full Mouth Rehabilitation – BDS5 Student Case Report

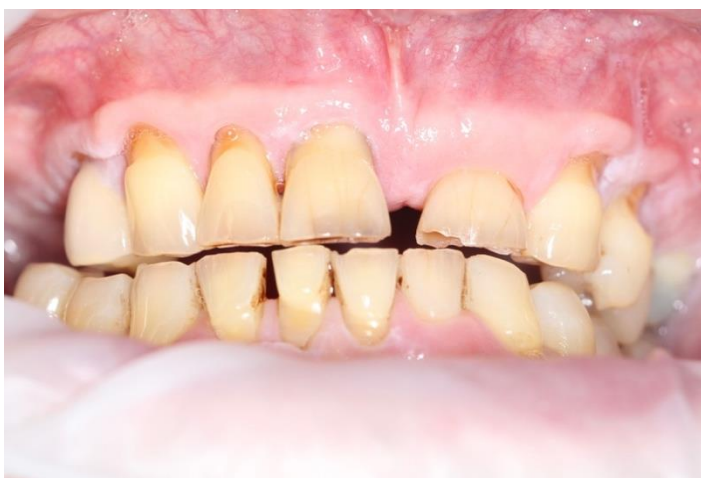
Image 2: Photograph of hard tissues. Patient has existing upper midline diastema. UR1 is Grade 3 mobile.

Upon examination, he has a moderately restored dentition and reports a history of bruxism with a previous prescription of a bilaminar splint. His oral hygiene is fair, his diet is low in sugar and not particularly abrasive. A white lesion is also present on the edentulous ridge in the UR6 area, which is currently under monitoring by the Oral Medicine department within the hospital for potential dysplasia. . The medical history is unremarkable otherwise, with the social history noting long-term heavy and regular nicotine and cannabis use. Fortunately, he quit smoking a few weeks before his first appointment. After further discussion, he expressed concern about the mobility of his front tooth, and he reported severe swelling and pain in the upper right quadrant from a posterior tooth that started a few days ago.

No TMJD or lymphadenopathy was noted, and gingivae appear healthy. There is hyperkeratosis of the UR6 area, consistent with his existing diagnosis but otherwise no mucosal lesions. The teeth present are as follows; UR1, UR2, UR3, UR4, UL1, UL3, UL4, UL5, UL7, LL1, LL2, LL3, LL4, LL5, LL6, LL7 and LR1, LR2, LR3, LR4, LR5, and LR7. Radiographs were taken as a baseline and a periapical view was taken of UL7 and UR1 to investigate the cause of symptoms and mobility. After the first appointment, the patient was diagnosed with the following: generalised periodontitis stage 4 grade C risk factor of ex-smoker, UR7 endo-perio lesion (grade 3 no root damage), UL3 secondary caries, UL2 fracture into dentine, generalised TSL BEWE score 2, distinct defect, hard tissue loss <50% of the surface area and UR1 chronic apical periodontitis.

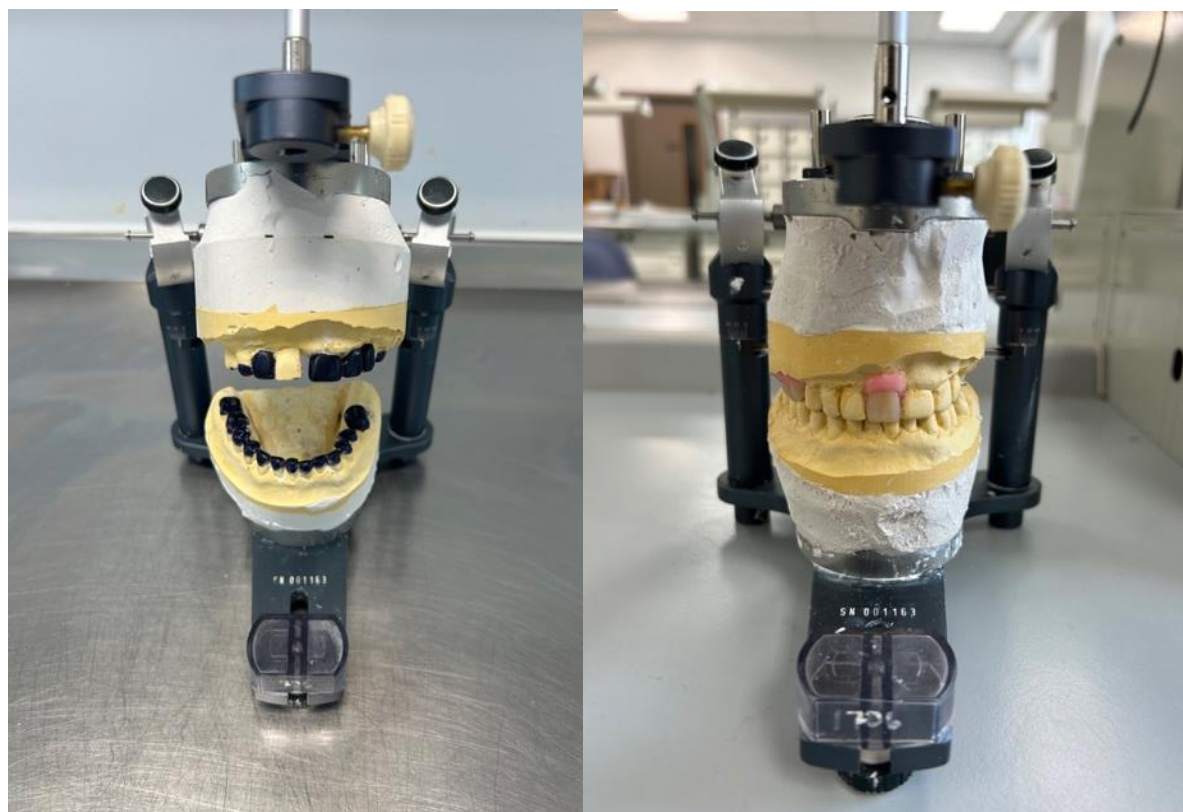
Image 3: The image on the left shows the diagnostic wax up. This was then duplicated to create the image on the right with the new immediate denture in wax.

As part of the next stage, a diagnostic wax-up was created to plan the build-up existing teeth and final aesthetics of each tooth pre-appointment. These casts were then duplicated using the agar technique to create an immediate denture matching the new OVD as well as a bilaminar splint to protect the final build-up. Another copy of the splint was requested to be used as an injectable mould to use during treatment. The injectable composite resin technique is a method that uses a transparent index for accurate and predictable translation of a diagnostic wax-up into composite restorations without the need for tooth preparation (Geštakovski, 2019). Once the lab work was completed, the patient was booked into the next available appointment.

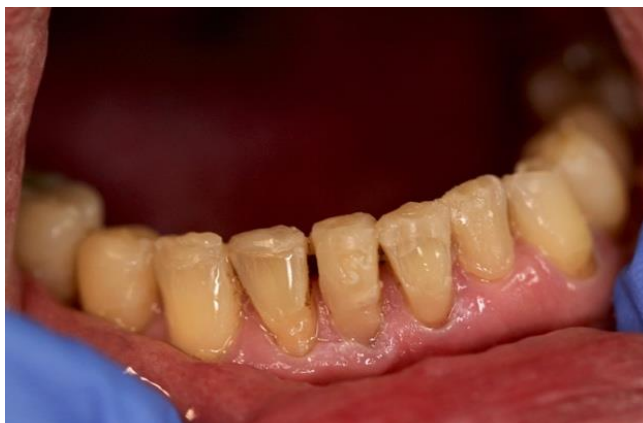
Image 4: Anterior mandibular teeth built up with composite. Contact of LL1 re-established at one appointment before polishing.

At this stage, the injection mould and immediate denture had been created. Treatment was carried out in stages as follows:

1. Teeth cleaned and dried.
2. Isolation of individual teeth achieved with cotton wool rolls in the buccal sulcus and lingual surfaces. The patient had a tongue thrust and this was managed by the assistant using a dental mirror.

3. PTFE tape was disinfected and used for teeth isolations.
4. The injection mould was initially sectioned into three pieces (two posterior and one anterior) and then seated. A small hole was created in the highest accessible point on occlusal surface of teeth and in the incisal edge for the anterior teeth with a flame-shaped bur.

5. Shade A4 flowable composite selected, closest match. The tip of the cartridge was inserted into the mould and slowly injected.
6. Composite set for 10 seconds with the injection mould seated and 20 seconds with the mould removed.

7. Insulations and excess materials were removed on each step.
8. Restorations shaped with coarse Soflex discs and finished with polishing spirals under water spray condition.

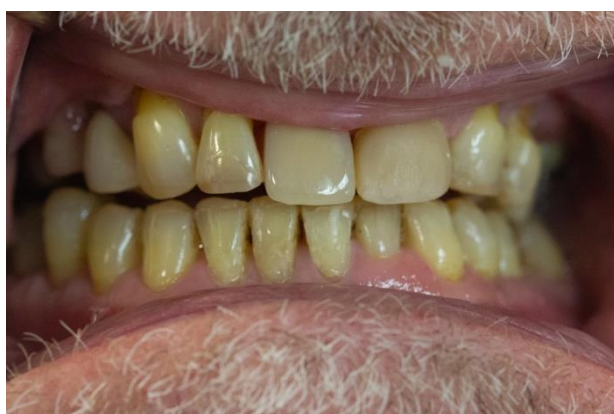
Image 5: Final outcome. Occlusion checked for even contacts with articulating paper.

The general shape of the maxillary and mandibular teeth was achieved at the first appointment as well as the extraction of UR1. Unfortunately, the immediate denture did not fit, and so impressions were retaken at the next appointment. This was due to the shrinkage of the cast. After impressions, the anatomy and colour of each individual tooth were established, and the immediate denture was fitted. The patient was very happy with the final result.
